Howard county Legislation

Testimony for Ron Peters in support of the Countys plan

Oversight Hearing on Repeated Flooding in Ellicott City, MD:

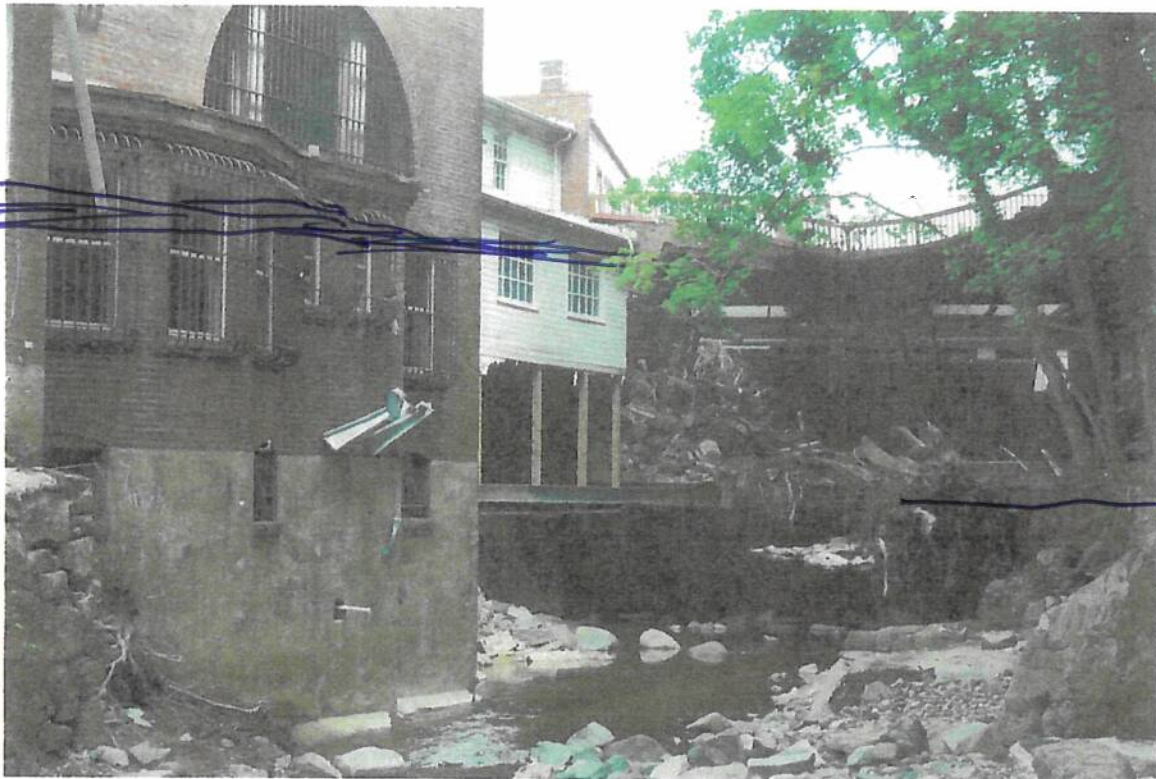
Water
Depth

This shows the rock debris field that was left after the 2018 flood, 50 yards upstream from Caplan's. This whole channel from the river up to the New cut and on up to Ellicott Mills drive needs to be dredged and cleaned out

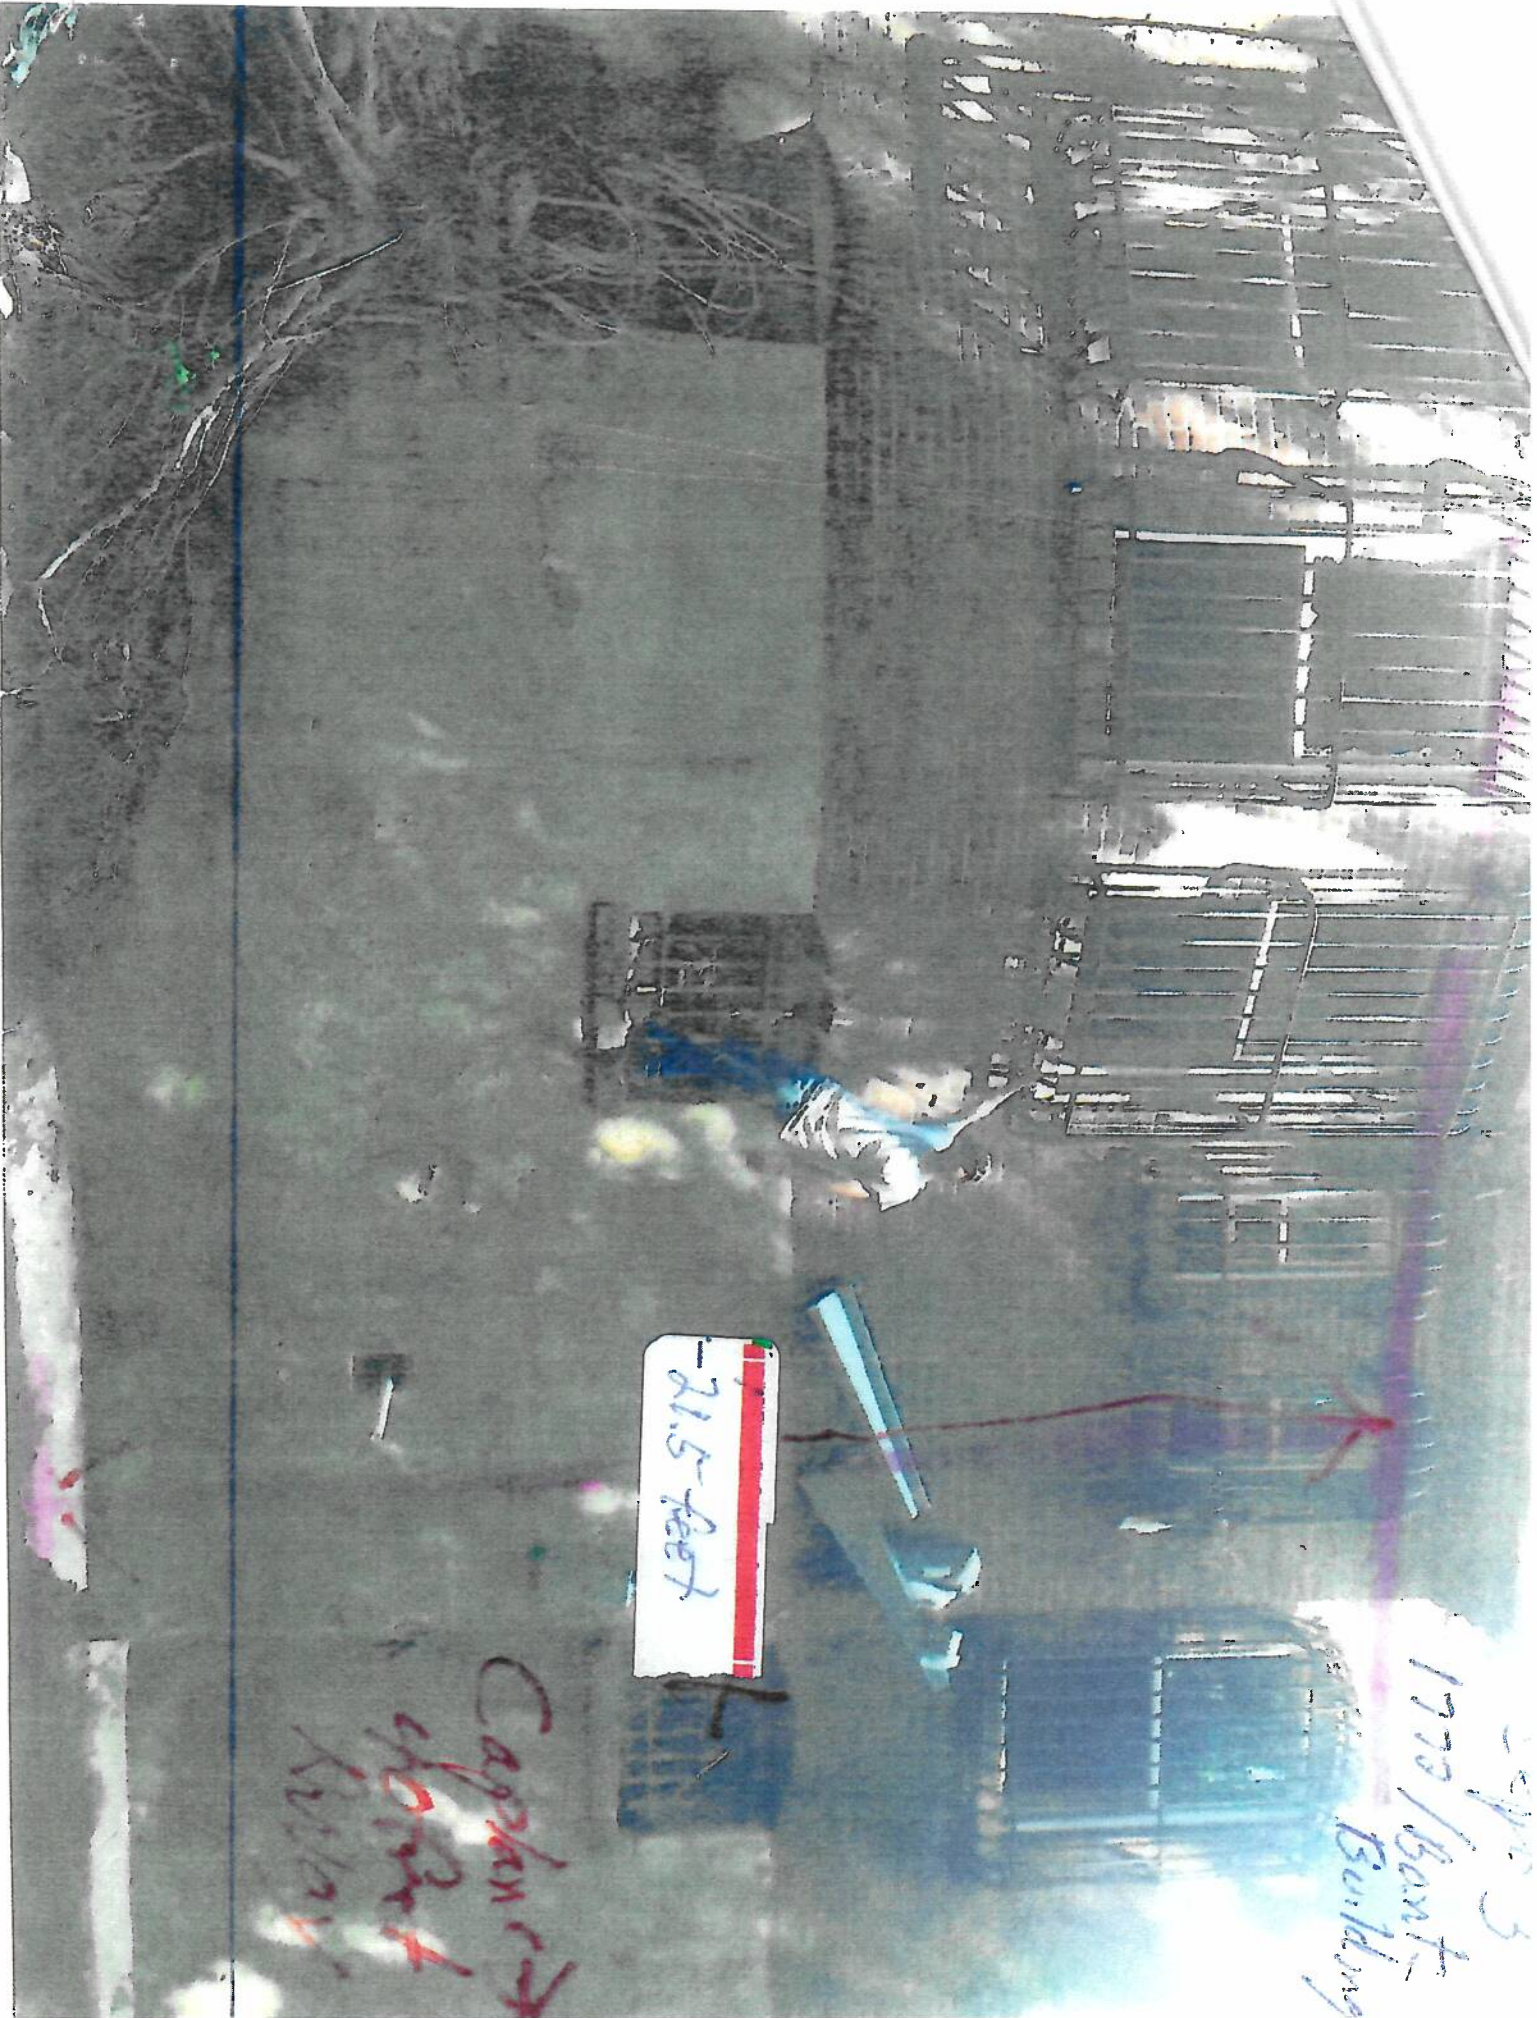
Water 21.5 feet High

This photo shows the logs and trees that broke thru Caplan's wall, the water level was at the top of the windows of the old bank building, about 20 feet deep. This is the beginning of where the Tiber goes under the buildings on lower mainstreet. The County has recommended taking these 10 buildings down to open the channel and improve the flow of the Tiber to the Patapsco river, this would also remove several hundred people from harms way when the next flood happens. The flood happened on Sunday, if it had been Saturday, MS Fit would have had a class of women exercising in this building, while children were being watched in the provided day care. This could have been a horrible tragedy. The removal of these buildings is necessary of which only one is historic and could be taken down and rebuilt.

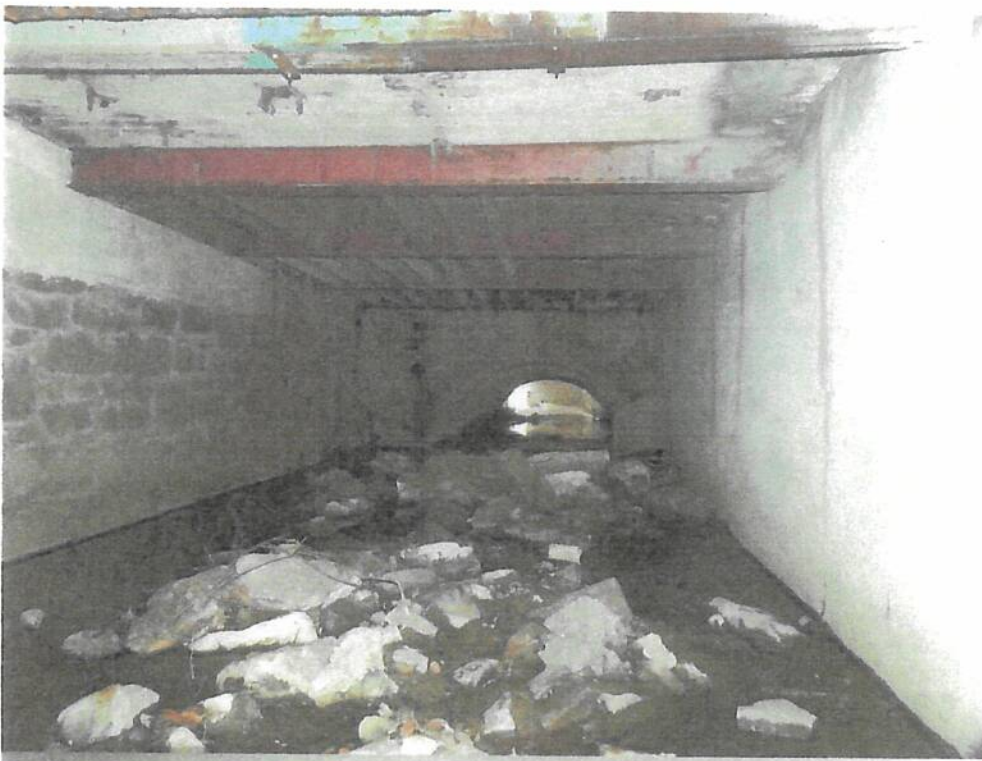
This is the 108-84 culvert , once 108 inches in diameter it was reduced in size in 1985, to 84 inches , it will not handle the current runoff volume , which includes the extreme amounts of UNMITIGATED water coming off of route 40 and routes 29 , these roads have been enlarged and widen several times with no SWM added by the State. All that runoff floods into Ellicott City. This is located in the 8600 block of Westend. It is scheduled for removal starting late next year and replaced with a bridge, and the lower 500 feet of culvert removed and the channel day lighted . There is a camera viewing this area and shows how severe the flooding was in 2018

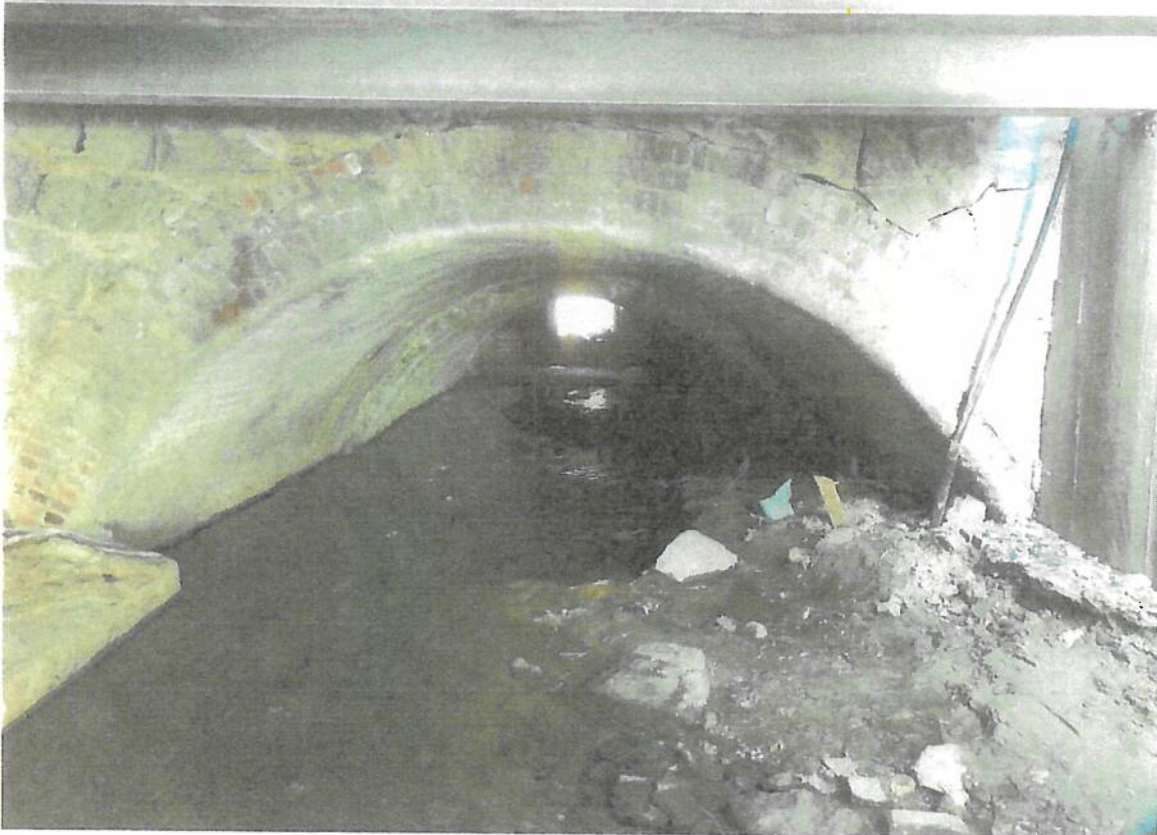
This is the channel and Arched culvert under main street. The culvert restricts the volume of water flowing thru the Hudson channel , it clogs

up with debris and causes extreme flooding starting at Court Ave and rushing down main street taking vehicles with it and is the main cause of flooding into the buildings in this area . This needs to be removed and the channel day lighted and dredged to deepen the channel , there is more than 3 feet of sediment under the culvert now , along with rocks and bricks , it all needs to be cleaned out for maximum flow

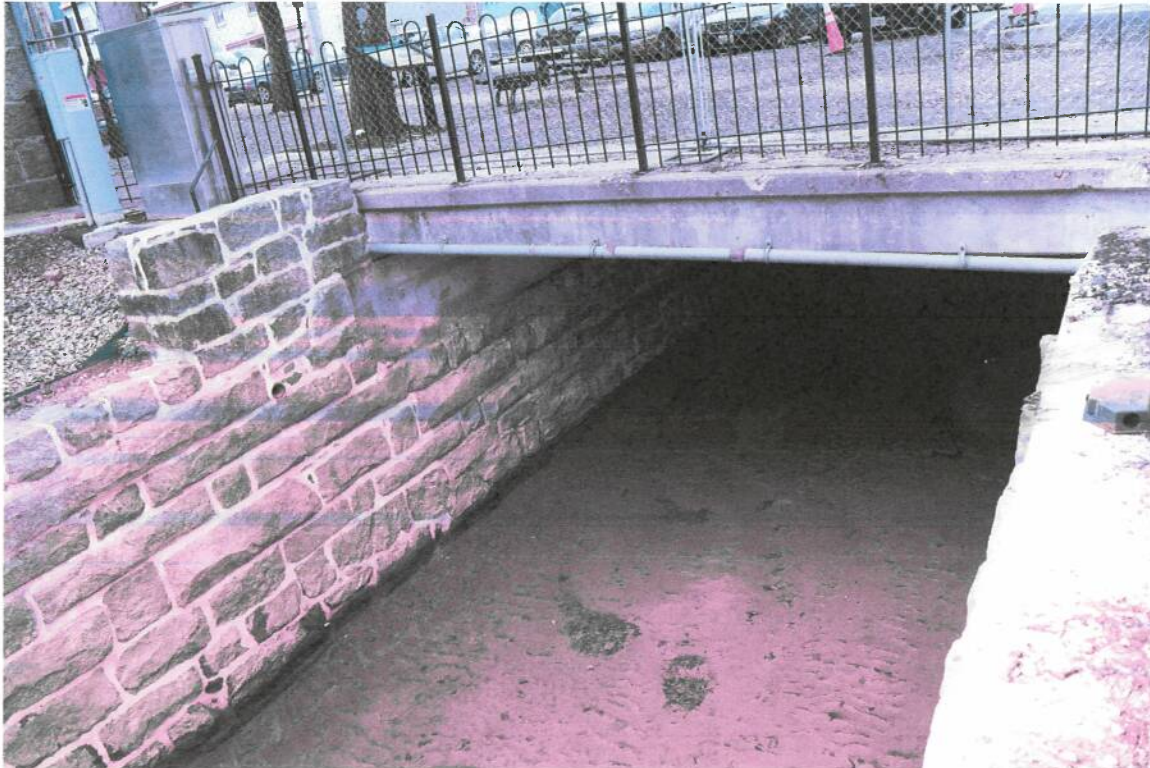
THIS IS THE MARYLAND AVE. CULVERT AT THE PATAPSCO
IT IS 18FT WIDE BY 8.5 FEET TALL = 153 SQUARE FEET
THIS WILL ALLOW 1683 CFS OF WATER TO PASS THROUGH AT A VELOCITY OF
11FPS . THERE WAS A TOTAL OF 8170 CFS IN 2016 FLOWING THROUGH THIS
AREA . IN 2018 THERE WAS 12,480 CFS FLOWING THROUGH THIS AREA . THERE
WOULD HAVE TO BE 8 CULVERTS THIS SIZE TO CARRY ALL THAT FLOW . THERE
IS NOWHERE TO PUT 8 CULVERTS THIS SIZE TO THE RIVER . SO THERE WILL
ALWAYS BE WATER FLOODING LOWER MAIN STREET , WHETHER FROM TOP
DOWN FLOODING OR RIVER UP. REMOVING THE BUILDINGS WILL ALLOW THE
WATER TO SPREAD OUT AND SLOW DOWN DECREASING DAMAGE DONE TO THE
REMAINING BUILDINGS

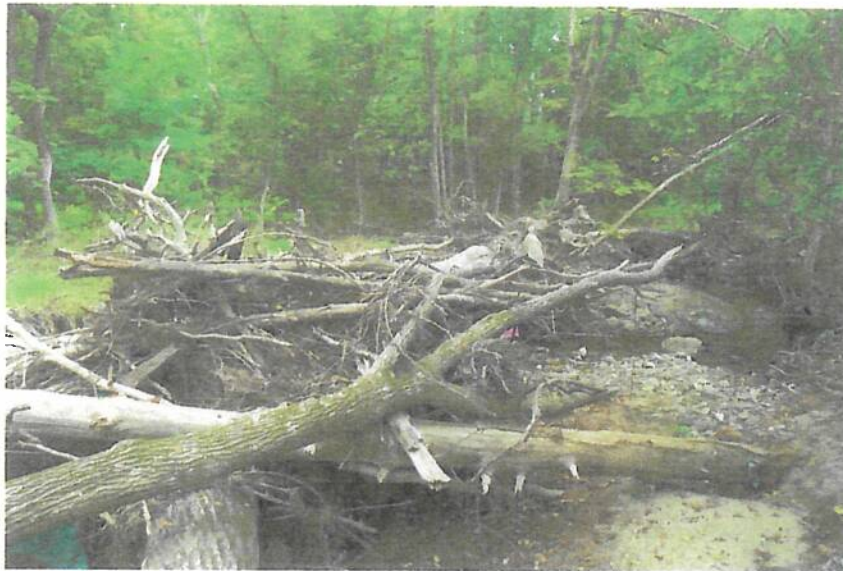
Photo 1

This is a log jam along the Autumn hill branch about 400 yards above the New Cut branch , these are the type of debris that took out the upstream wall at Caplans. They need to be removed , photo taken Aug 12,2018

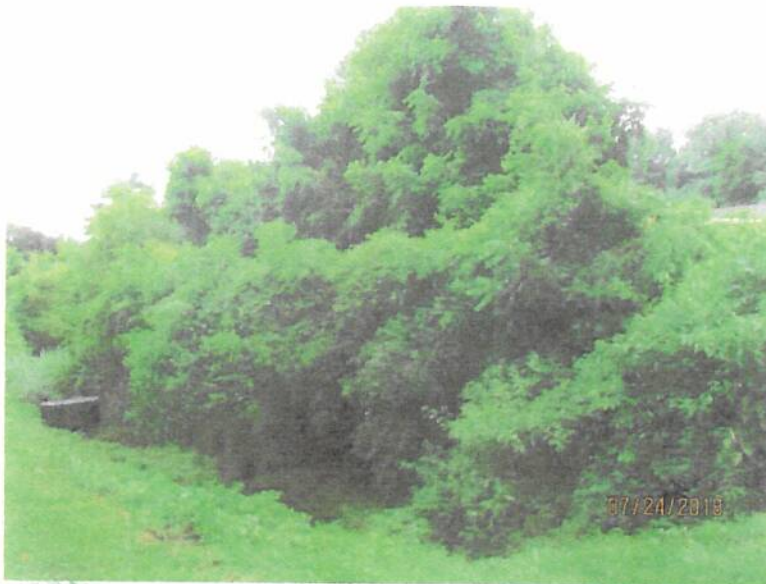
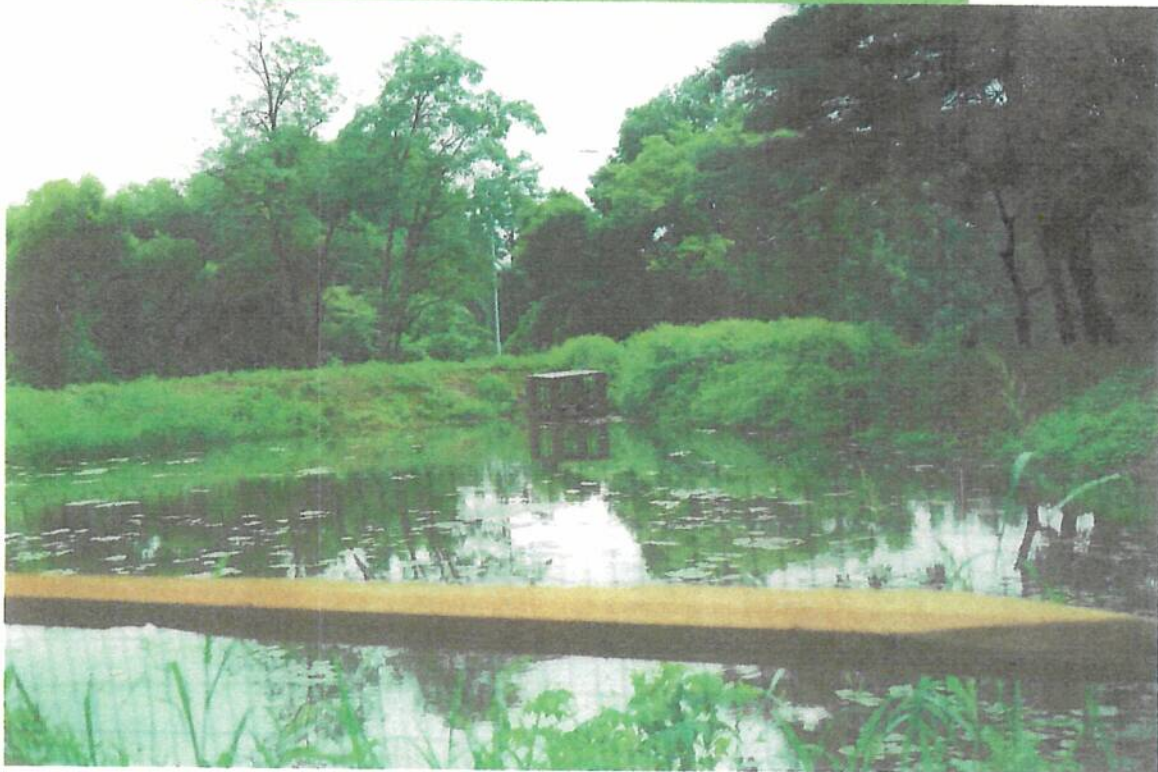
This is another example of fallen trees and logs in the Autumn hill branch
That needs to be cleaned up. 8-12-2018

The above photos show two SWM facilities in the Hudson watershed , one is full , not working properly and the other is located 100 yards away and is hard to locate and not maintained properly . The 64 current SWM facilities need to be inspected and recommendations given to improve their function
