# County Council of Howard County, Maryland

## Resolution No. 155 -2021

A RESOLUTION supplementing and amending the Historic Sites Inventory for Howard County by adding the Treakle Farm and the Duvall Family Farm to the Inventory and by amending address information related to properties already on the Inventory.

**HO-1165, Treakle Farm  
4797 Sheppard Lane, Ellicott City, MD  
Tax Map: 29, Parcel: 25**

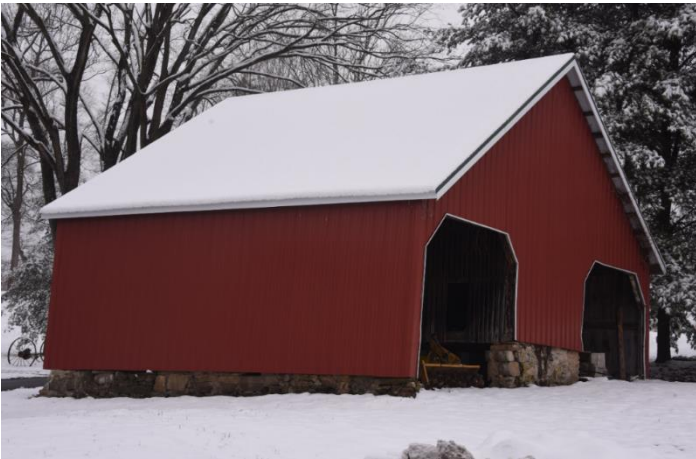
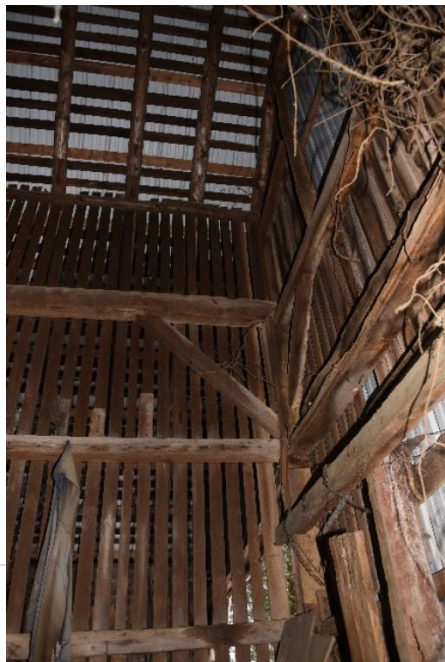
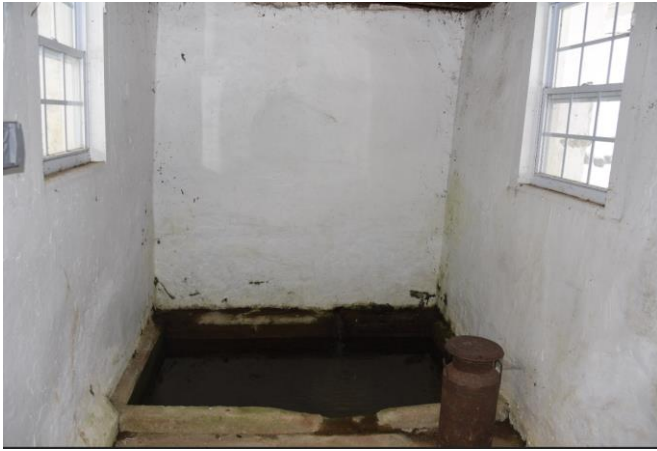
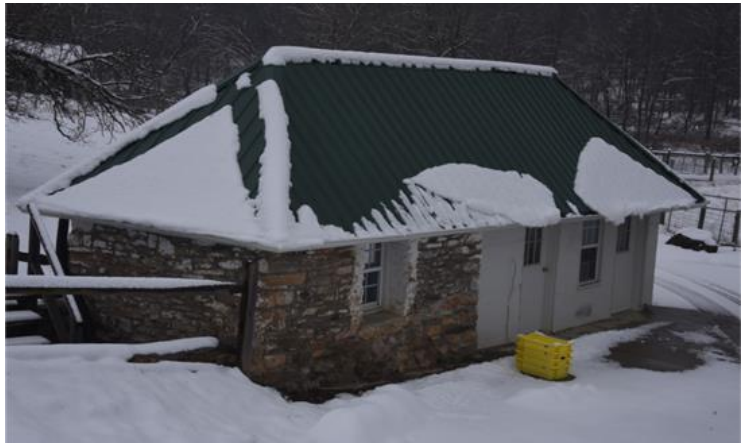
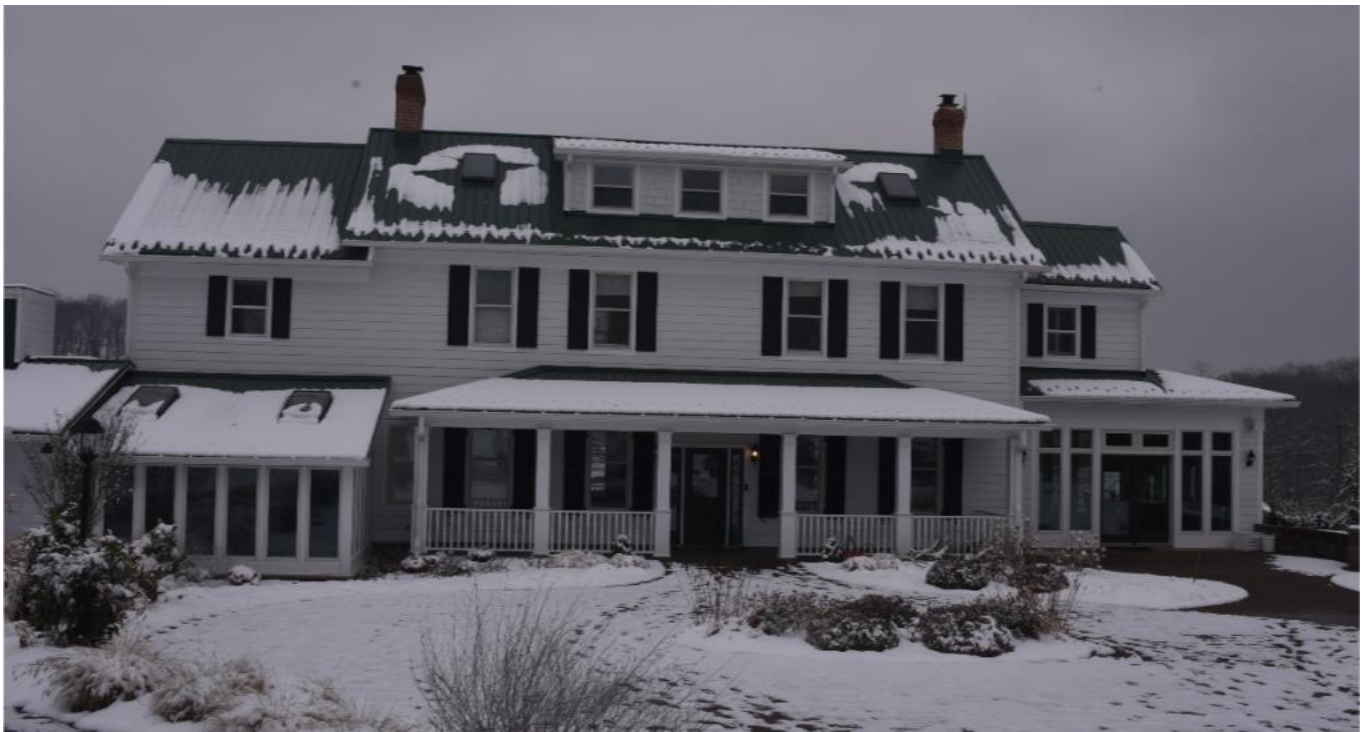
The Hay Barn is a one-story, three-bay by one-bay frame structure with most of the foundation hidden below the current grade and the little that is exposed has a new stone veneer. The exterior has new metal siding and new roll-up glazed metal doors in the center of the east and west walls, flanked by new windows. The gambrel roof has new v-crimp metal roofing and a ridge that runs north-south. The north gambrel end has a cantilevered hood for the hay track to pass outside. The interior has a concrete floor and horizontal boards lining the walls. It is built with a circular-sawn heavy-timber frame of Queen posts with up-braces. The Queen posts above the girt are offset to the outside of the posts below the girt. The upper posts support purlins at the break in the gambrel, with up-braces to the purlins. A shorter, non-historic gable-roofed addition is attached to the north end of the east elevation.

The wagon shed and corn crib is a one-story, three-bay by three-bay frame structure with a rubble stone foundation, metal siding, and a gable roof with an east-west ridge. It has the crib in the center with a shed to each side. It is built with a hewn heavy timber braced frame that is mortised and tenoned and pegged; the braces are sawn. The north and south walls each have four posts with girts running to the crib, and the two center girts of the south shed have two iron eyes through them to support a wood hoist, both of which are missing. The north shed has the east-center girt cut out but the west-center girt still has the wood hoist in place. The north plate has rotted away and been patched. The rafters are three-quarter round logs that are squared at the foot, and they support shingle lath. The crib has vertical slats fastened with cut nails. The west end of the crib is divided in half by a low wall of slats.

The granary is a one-story, one-bay by one-bay frame structure with four rubble stone piers that run north south for the whole depth of the building. The walls are covered with metal siding and the gable roof has v-crimp metal and an east-west ridge. The north elevation has a new door in the center. Both the east and west elevations have a new six-over-six sash on the first story and another in the gable end. The south elevation has a similar sash centered on the wall. The interior has been completely renovated leaving no clear evidence of the original function of the building, which is conjectured to be a granary.

The springhouse is located about 150 feet east of the house, just northwest of the Dairy Barn, is a one-story, four-bay by one-bay structure with the west bay of rubble stone and the three eastern bays of block. It has a hip roof with v-crimp metal. The south elevation has a new six-over-six sash in the west bay, a new door with six lights in the west-center bay, a new six-over-six sash in the east-center bay, and a new door with six lights in the east bay. The east elevation has a new six-over-six sash and the west elevation has no opening. There is a pit dug into the hillside at the west end with a rubble stone wall and a springhead with opening at the west end of the pit. There are new wood steps down into the pit. The north elevation has a new six-over-six sash in the west and west-center bays and no other openings. The east bay is deeper than the center and west bays.

The Dairy Barn is located about 5 feet southeast of the springhouse and is a two-story, 18-bay by three-bay structure with a block lower story and a gambrel-roofed upper story with a kick at the eaves and v-crimp metal roofing. The gambrel ends have metal siding. The west elevation has a new metal door in the north bay and new six-over-six sash in the remaining bays. The south elevation has a center door on rollers on the lower story, with a new door with nine lights to the west and a new six-over-six sash to the east. The upper story has paired doors on T hinges in the center with a small one-over-one sash to each side. There is a cantilevered hood for a hay track at the ridge. The east elevation has no opening in the north bay, there are five new six-over-six to the south, then four closed-off bays and seven bays with new sash. The south bay has a doorway that leads to a concrete silo with steel hoops and a metal dome roof. The north elevation of the barn has a center door on rollers on the lower story, with a new six-over-six sash to each side. The upper story has two small one-over-one sash. The lower story interior has had all the stanchions removed and new frame walls installed running north-south to create a long center aisle. There is some horizontal board sheathing on the walls and insulation and some plywood on the ceiling. The upper story is one open space with exposed 2 by 4 rafters that have a strut across the break in the roof and a short collar at the ridge that supports the hay track. The trolley and fork are still in place. There is a tongue-and-grooved wood floor.

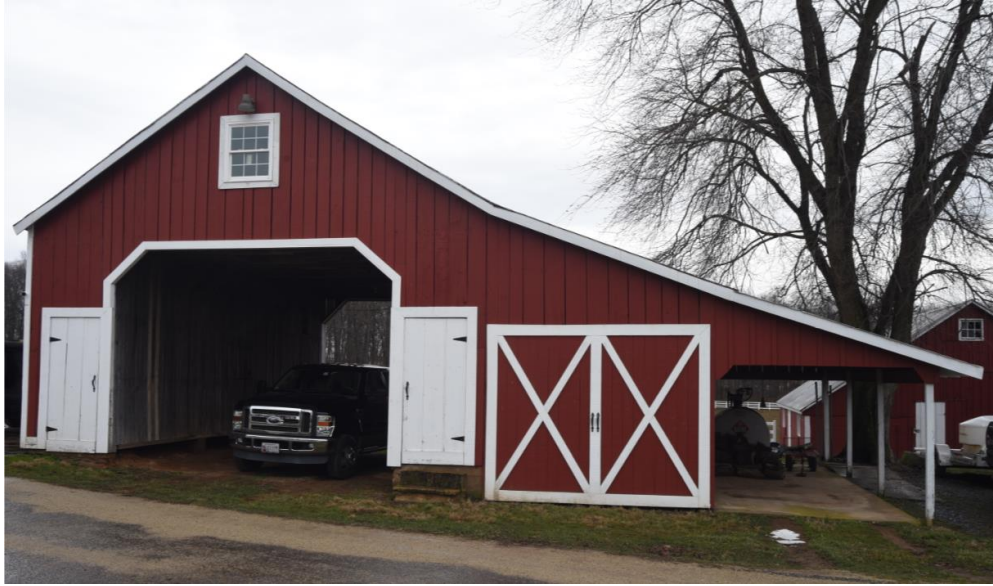
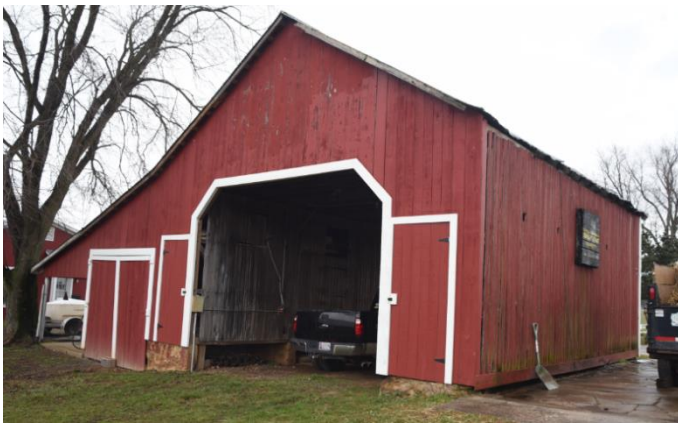
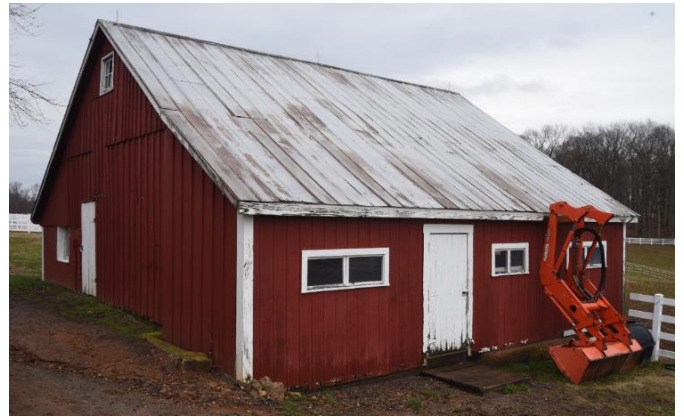
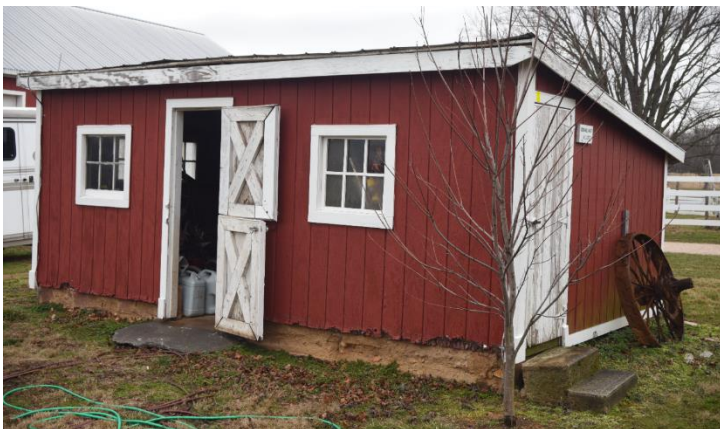
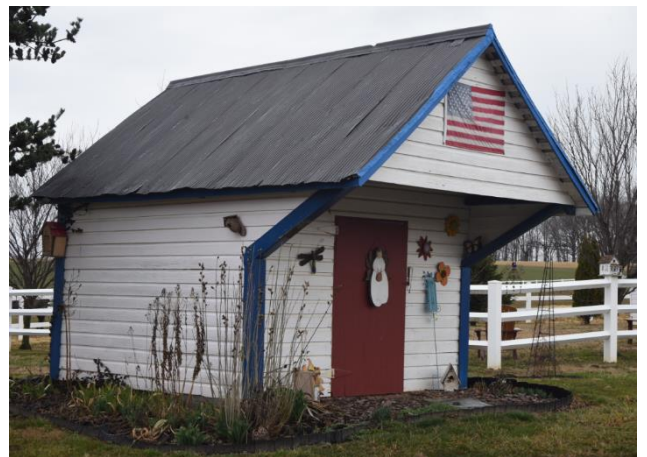
**HO# 1177, Duvall Family Farm  
2435 Duvall Road, Woodbine, MD  
Tax Map: 13, Parcel: 107**

The Duvall Family Farm is located at 2435 Duvall Road, about one mile northwest of Daisy. The historic house was demolished c. 2008-2010 but several historic farm buildings survive, including a smokehouse, wagon shed, hay barn and poultry house. The farm had been in the Talbert family in the late nineteenth century and was reduced from 187 acres to 138 when sold to Samuel and Beulah Davis in 1899. Nine years later they sold to Clinton Duvall who farmed here with his wife Mary until his death in the 1920s. Mary and her young son, John, then took over the farm and Mary left it to him at her death in 1941. John and his wife, Elizabeth, retained the farm until 1960. There were undoubtedly earlier buildings on the farm but these seem to have been replaced, with the existing structures mostly having concrete foundations and wire nails that strongly suggest that the Duvalls embarked on a campaign of farm improvements shortly after acquiring the property. The early twentieth century was one of several periods of intense modernization of farms in the history of central Maryland and the Duvall farm buildings seem to fit within this context. It remained a family farm with a diverse production during the Duvall ownership and the surviving buildings reflect that.
