Resolution No. 155 -2021

A RESOLUTION supplementing and amending the Historic Sites Inventory for Howard County by adding the Treakle Farm and the Duvall Family Farm to the Inventory and by amending address information related to properties already on the Inventory.

**HO-1165, Treakle Farm
4797 Sheppard Lane, Ellicott City, MD
Tax Map: 29, Parcel: 25**

**HO# 1177, Duvall Family Farm
2435 Duvall Road, Woodbine, MD
Tax Map: 13, Parcel: 107**

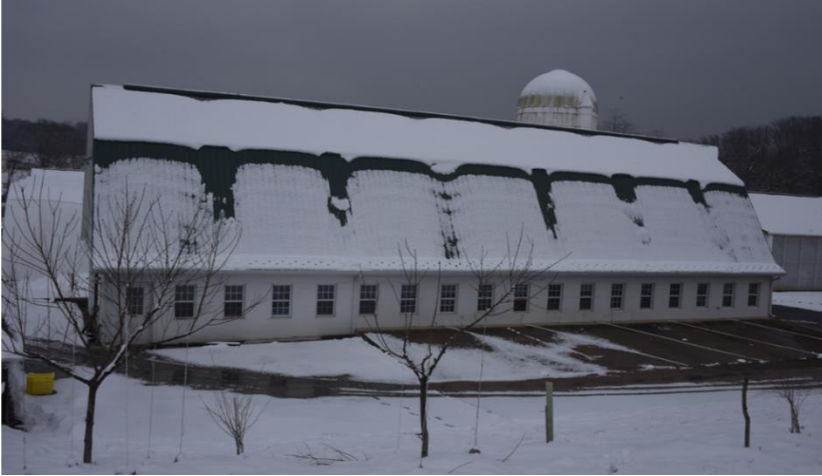
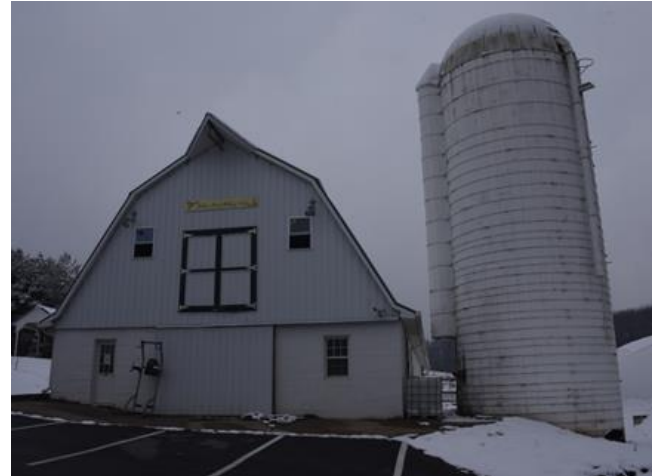
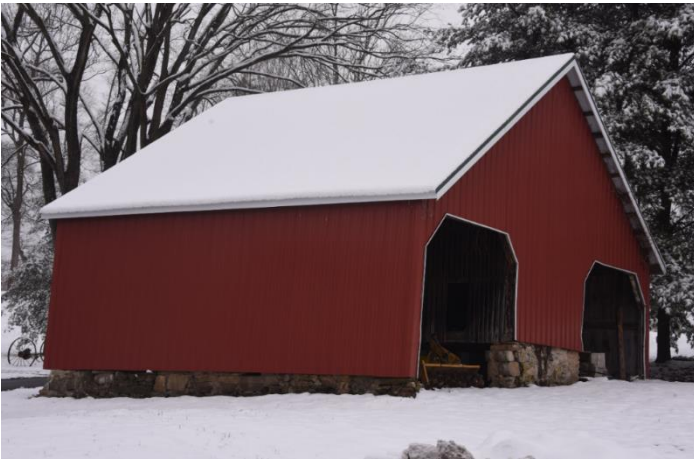
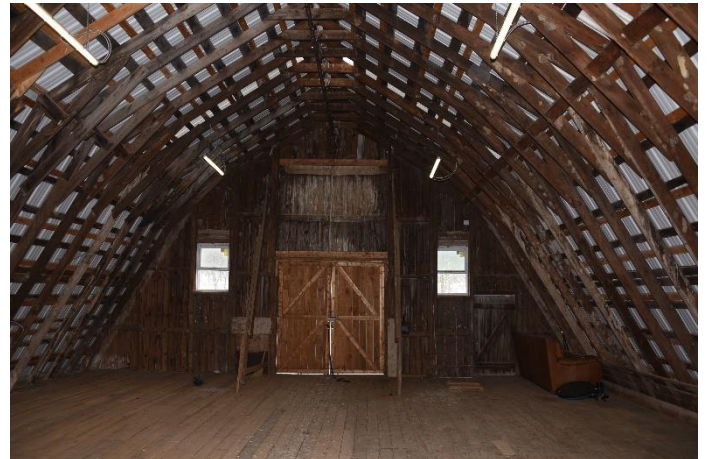
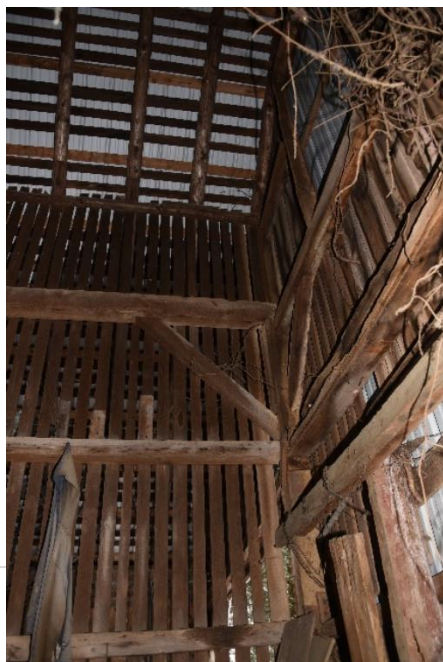
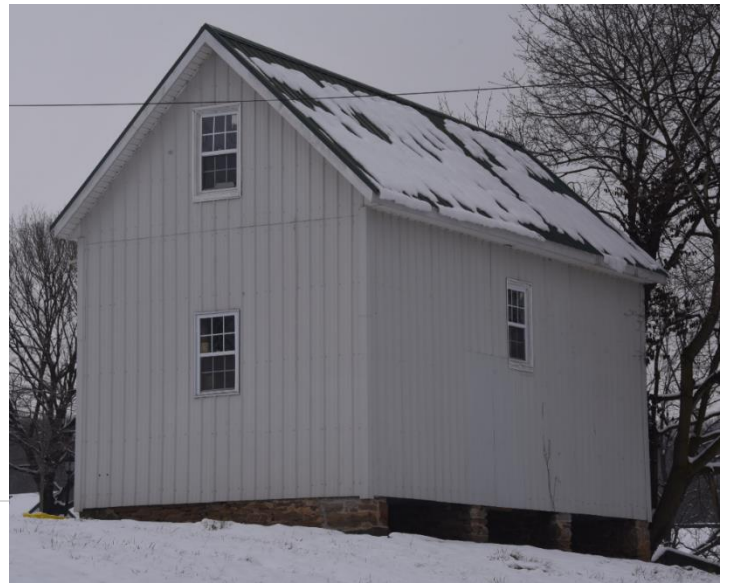
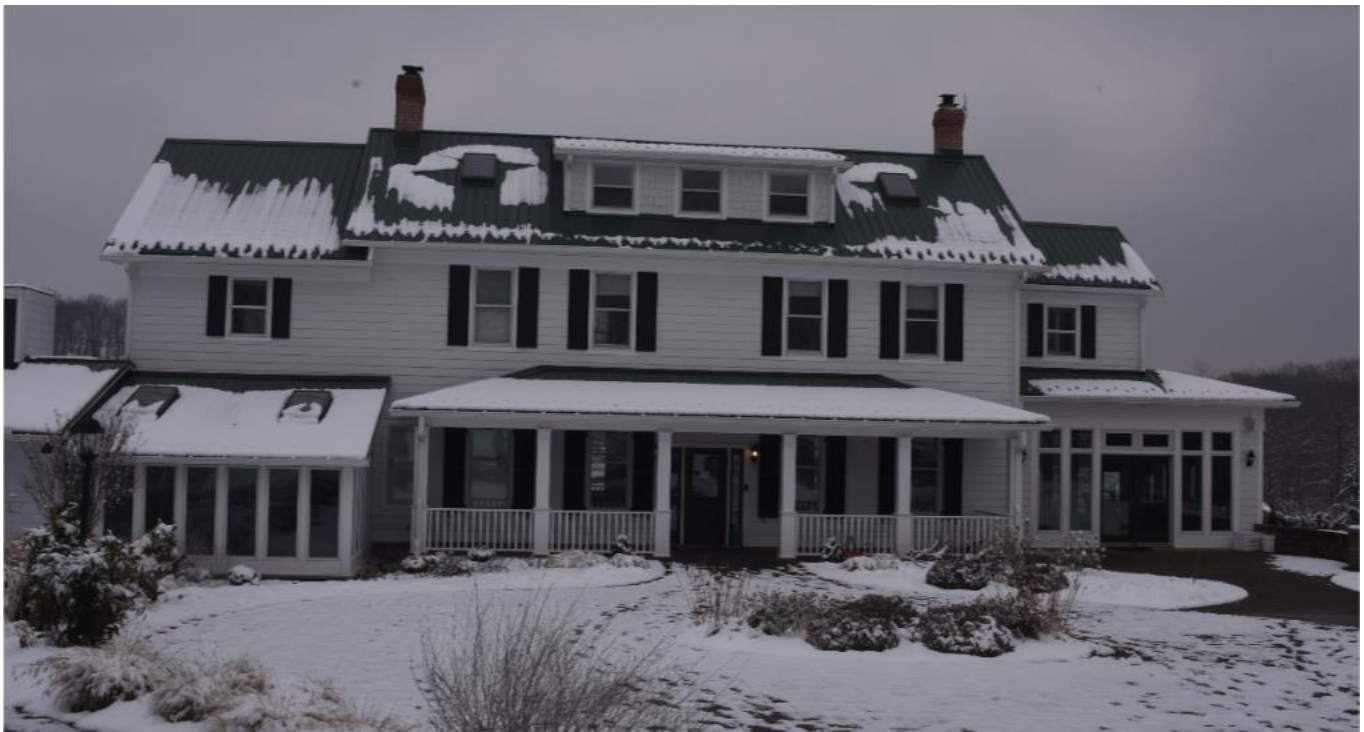
There are several historic structures on the property, with the wagon shed and springhouse dating back to 1877.

The Hay Barn is a one-story, three-bay by one-bay frame structure with most of the foundation hidden below the current grade and the little that is exposed has a new stone veneer. The exterior has new metal siding and new roll-up glazed metal doors in the center of the east and west walls, flanked by new windows. The gambrel roof has new v-crimp metal roofing and a ridge that runs north-south. The north gambrel end has a cantilevered hood for the hay track to pass outside. The interior has a concrete floor and horizontal boards lining the walls. It is built with a circular-sawn heavy-timber frame of Queen posts with up-braces. The Queen posts above the girt are offset to the outside of the posts below the girt. The upper posts support purlins at the break in the gambrel, with up-braces to the purlins. A shorter, non-historic gable-roofed addition is attached to the north end of the east elevation.

The wagon shed and corn crib is a one-story, three-bay by three-bay frame structure with a rubble stone foundation, metal siding, and a gable roof with an east-west ridge. It has the crib in the center with a shed to each side. It is built with a hewn heavy timber braced frame that is mortised and tenoned and pegged; the braces are sawn. The north and south walls each have four posts with girts running to the crib, and the two center girts of the south shed have two iron eyes through them to support a wood hoist, both of which are missing. The north shed has the east-center girt cut out but the west-center girt still has the wood hoist in place. The north plate has rotted away and been patched. The rafters are three-quarter round logs that are squared at the foot, and they support shingle lath. The crib has vertical slats fastened with cut nails. The west end of the crib is divided in half by a low wall of slats.

The granary is a one-story, one-bay by one-bay frame structure with four rubble stone piers that run north south for the whole depth of the building. The walls are covered with metal siding and the gable roof has v-crimp metal and an east-west ridge. The north elevation has a new door in the center. Both the east and west elevations have a new six-over-six sash on the first story and another in the gable end. The south elevation has a similar sash centered on the wall. The interior has been completely renovated leaving no clear evidence of the original function of the building, which is conjectured to be a granary.

The springhouse is located about 150 feet east of the house, just northwest of the Dairy Barn, is a one-story, four-bay by one-bay structure with the west bay of rubble stone and the three eastern bays of block. It has a hip roof with v-crimp metal. The south elevation has a new six-over-six sash in the west bay, a new door with six lights in the west-center bay, a new six-over-six sash in the east-center bay, and a new door with six lights in the east bay. The east elevation has a new six-over-six sash and the west elevation has no opening. There is a pit dug into the hillside at the west end with a rubble stone wall and a springhead with opening at the west end of the pit. There are new wood steps down into the pit. The north elevation has a new six-over-six sash in the west and west-center bays and no other openings. The east bay is deeper than the center and west bays.

The structure was built in three stages, from west to center to east. The west section has a concrete floor and trough at the west end and water still flows into it. The walls are parged. The east wall was completely taken down. The ceiling has hewn joists with lath nails and plaster burns. The original hip roof is still in situ. The rafters are sawn and two have a center tenon and peg at the ridge. They support alternating shingle lath and wider boards. The east end of the roof is captured within the addition and has circular-sawn wood shingles. Based on other nail holes, this was probably the second roof on the west section. The center section also has a hip roof, with the east end captured by the east addition. The joists and rafters are circular-sawn, with a ridge beam, and this is all re-used lumber. The sheathing boards are also re-used and there appears to be asphalt roll roofing. The

eastern wall is partially in place and it appears it had a window that was converted to a door. The eastern section is built with dimensional lumber and probably dates to when the Dairy Barn was built.

The Dairy Barn is located about 5 feet southeast of the springhouse and is a two-story, 18-bay by three-bay structure with a block lower story and a gambrel-roofed upper story with a kick at the eaves and v-crimp metal roofing. The gambrel ends have metal siding. The west elevation has a new metal door in the north bay and new six-over-six sash in the remaining bays. The south elevation has a center door on rollers on the lower story, with a new door with nine lights to the west and a new six-over-six sash to the east. The upper story has paired doors on T hinges in the center with a small one-over-one sash to each side. There is a cantilevered hood for a hay track at the ridge. The east elevation has no opening in the north bay, there are five new six-over-six to the south, then four closed-off bays and seven bays with new sash. The south bay has a doorway that leads to a concrete silo with steel hoops and a metal dome roof. The north elevation of the barn has a center door on rollers on the lower story, with a new six-over-six sash to each side. The upper story has two small one-over-one sash. The lower story interior has had all the stanchions removed and new frame walls installed running north-south to create a long center aisle. There is some horizontal board sheathing on the walls and insulation and some plywood on the ceiling. The upper story is one open space with exposed 2 by 4 rafters that have a strut across the break in the roof and a short collar at the ridge that supports the hay track. The trolley and fork are still in place. There is a tongue-and-grooved wood floor.
