Resolution No. 155 -2021

A RESOLUTION supplementing and amending the Historic Sites Inventory for Howard County by adding the Treakle Farm and the Duvall Family Farm to the Inventory and by amending address information related to properties already on the Inventory.

**HO-1165, Treakle Farm
4797 ~~4979~~ Sheppard Lane, Ellicott City,
MD Tax Map: 29, Parcel: 25**

**HO# 1177, Duvall Family Farm
2435 Duvall Road, Woodbine, MD
Tax Map: 13, Parcel: 107**

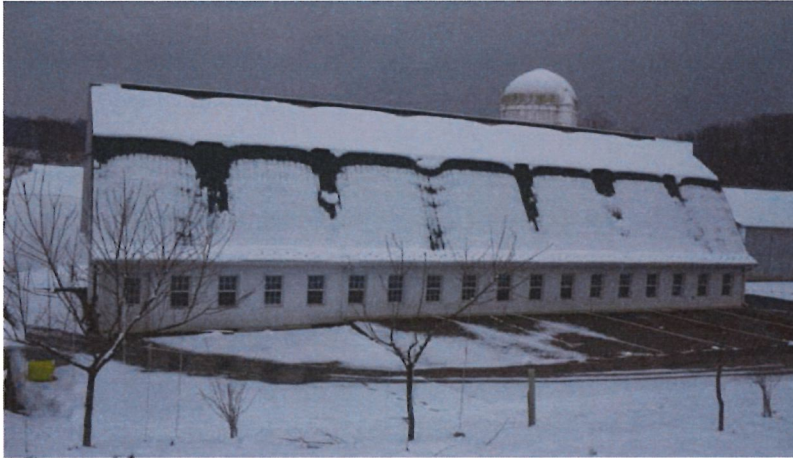
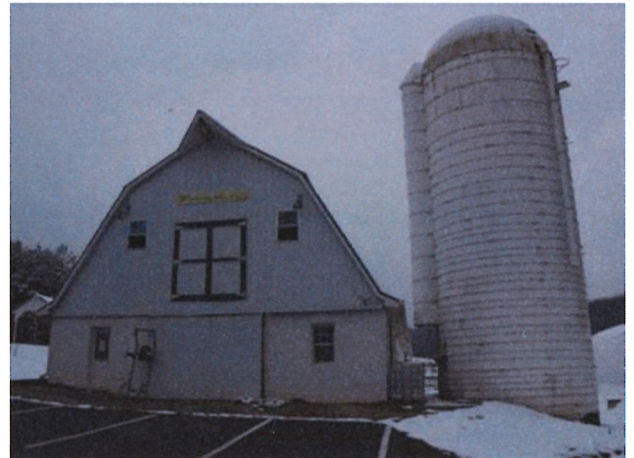
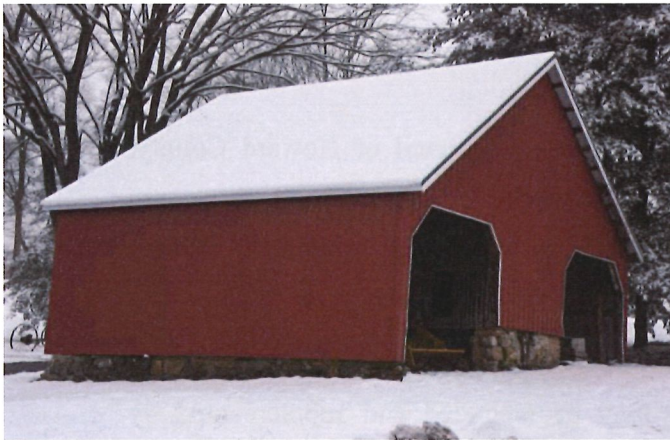
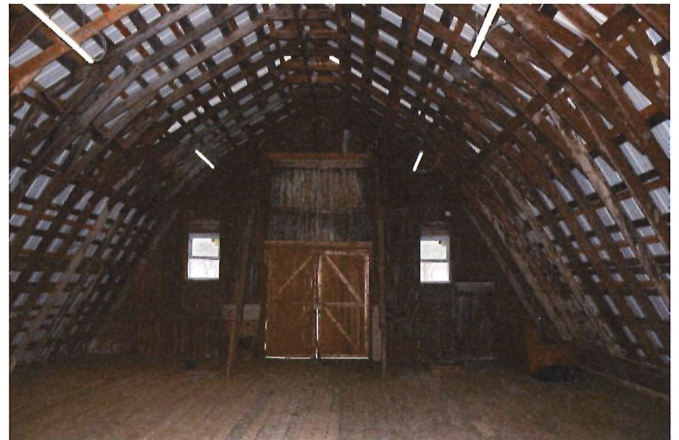
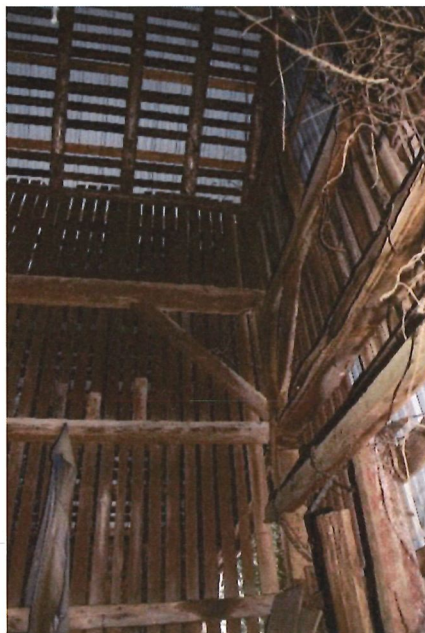
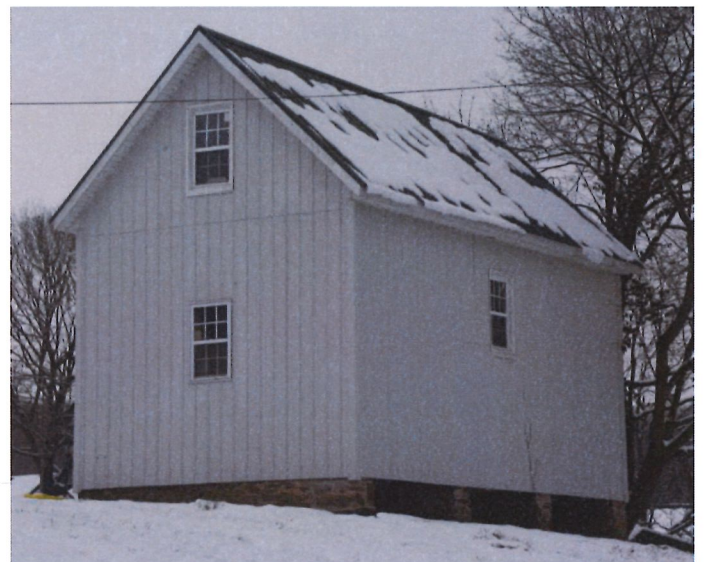
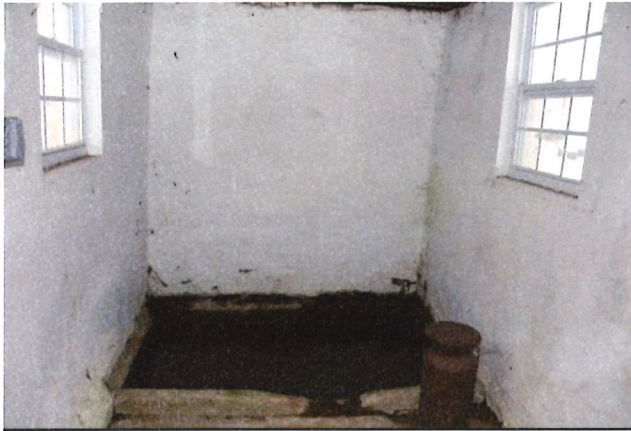
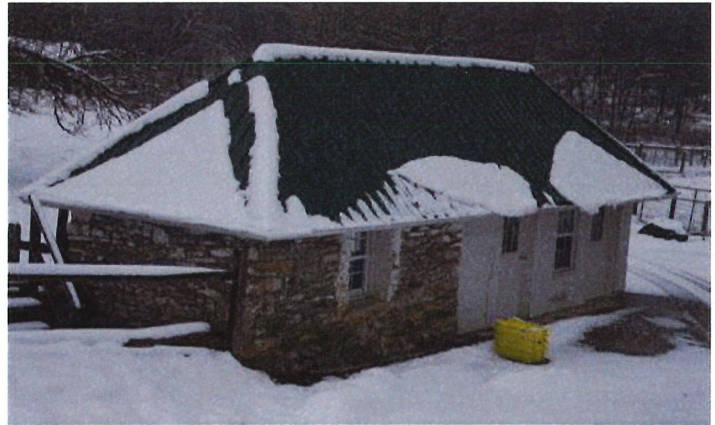
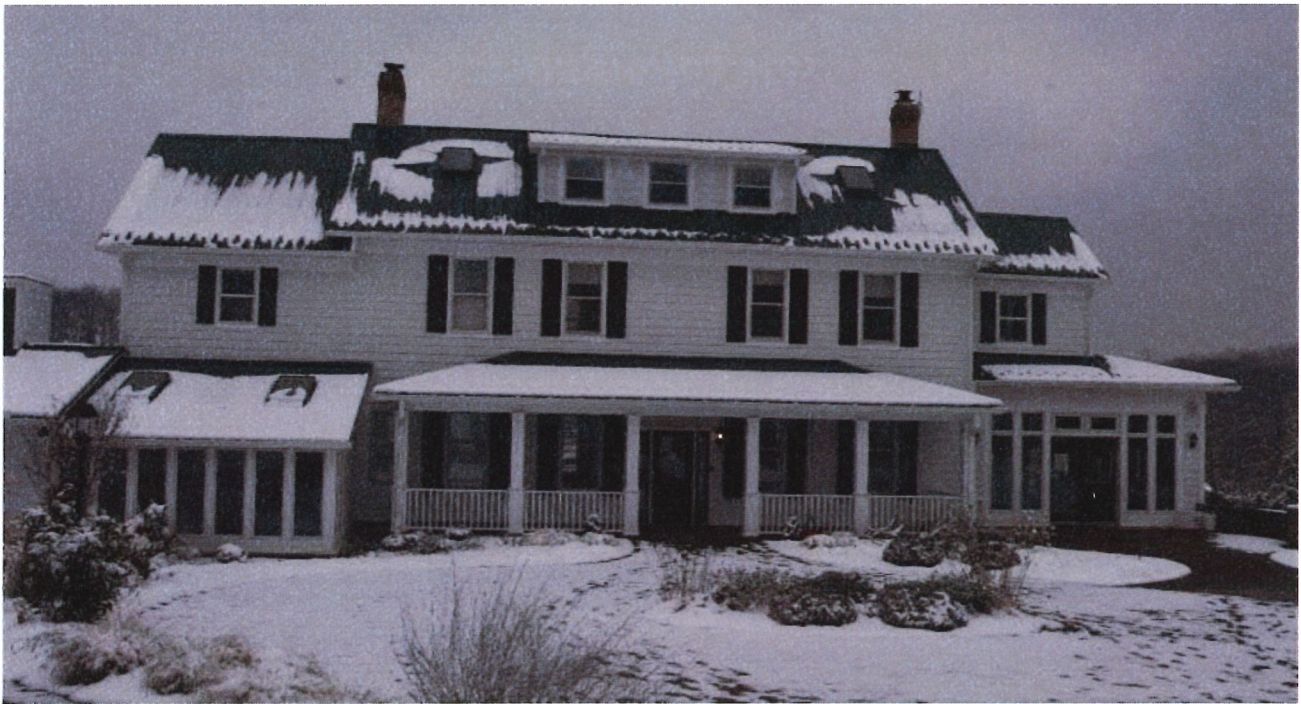
There are several historic structures on the property, with the wagon shed and springhouse dating back to 1877.

The Hay Barn is a one-story, three-bay by one-bay frame structure with most of the foundation hidden below the current grade and the little that is exposed has a new stone veneer. The exterior has new metal siding and new roll-up glazed metal doors in the center of the east and west walls, flanked by new windows. The gambrel roof has new v-crimp metal roofing and a ridge that runs north-south. The north gambrel end has a cantilevered hood for the hay track to pass outside. The interior has a concrete floor and horizontal boards lining the walls. It is built with a circular-sawn heavy-timber frame of Queen posts with up-braces. The Queen posts above the girt are offset to the outside of the posts below the girt. The upper posts support purlins at the break in the gambrel, with up-braces to the purlins. A shorter, non-historic gable-roofed addition is attached to the north end of the east elevation.

The wagon shed and corn crib is a one-story, three-bay by three-bay frame structure with a rubble stone foundation, metal siding, and a gable roof with an east-west ridge. It has the crib in the center with a shed to each side. It is built with a hewn heavy timber braced frame that is mortised and tenoned and pegged; the braces are sawn. The north and south walls each have four posts with girts running to the crib, and the two center girts of the south shed have two iron eyes through them to support a wood hoist, both of which are missing. The north shed has the east-center girt cut out but the west-center girt still has the wood hoist in place. The north plate has rotted away and been patched. The rafters are three-quarter round logs that are squared at the foot, and they support shingle lath. The crib has vertical slats fastened with cut nails. The west end of the crib is divided in half by a low wall of slats.

The granary is a one-story, one-bay by one-bay frame structure with four rubble stone piers that run north south for the whole depth of the building. The walls are covered with metal siding and the gable roof has v-crimp metal and an east-west ridge. The north elevation has a new door in the center. Both the east and west elevations have a new six-over-six sash on the first story and another in the gable end. The south elevation has a similar sash centered on the wall. The interior has been completely renovated leaving no clear evidence of the original function of the building, which is conjectured to be a granary.

The springhouse is located about 150 feet east of the house, just northwest of the Dairy Barn, is a one-story, four-bay by one-bay structure with the west bay of rubble stone and the three eastern bays of block. It has a hip roof with v-crimp metal. The south elevation has a new six-over-six sash in the west bay, a new door with six lights in the west-center bay, a new six-over-six sash in the east-center bay, and a new door with six lights in the east bay. The east elevation has a new six-over-six sash and the west elevation has no opening. There is a pit dug into the hillside at the west end with a rubble stone wall and a springhead with opening at the west end of the pit. There are new wood steps down into the pit. The north elevation has a new six-over-six sash in the west and west-center bays and no other openings. The east bay is deeper than the center and west bays.

The Dairy Barn is located about 5 feet southeast of the springhouse and is a two-story, 18-bay by three-bay structure with a block lower story and a gambrel-roofed upper story with a kick at the eaves and v-crimp metal roofing. The gambrel ends have metal siding. The west elevation has a new metal door in the north bay and new six-over-six sash in the remaining bays. The south elevation has a center door on rollers on the lower story, with a new door with nine lights to the west and a new six-over-six sash to the east. The upper story has paired doors on T hinges in the center with a small one-over-one sash to each side. There is a cantilevered hood for a hay track at the ridge. The east elevation has no opening in the north bay, there are five new six-over-six to the south, then four closed-off bays and seven bays with new sash. The south bay has a doorway that leads to a concrete silo with steel hoops and a metal dome roof. The north elevation of the barn has a center door on rollers on the lower story, with a new six-over-six sash to each side. The upper story has two small one-over-one sash. The lower story interior has had all the stanchions removed and new frame walls installed running north-south to create a long center aisle. There is some horizontal board sheathing on the walls and insulation and some plywood on the ceiling. The upper story is one open space with exposed 2 by 4 rafters that have a strut across the break in the roof and a short collar at the ridge that supports the hay track. The trolley and fork are still in place. There is a tongue-and-grooved wood floor.

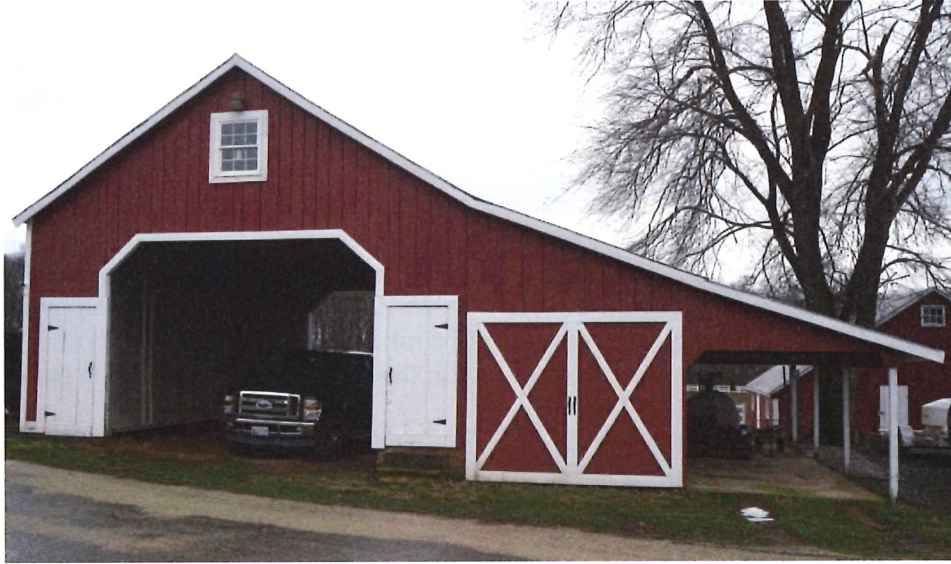
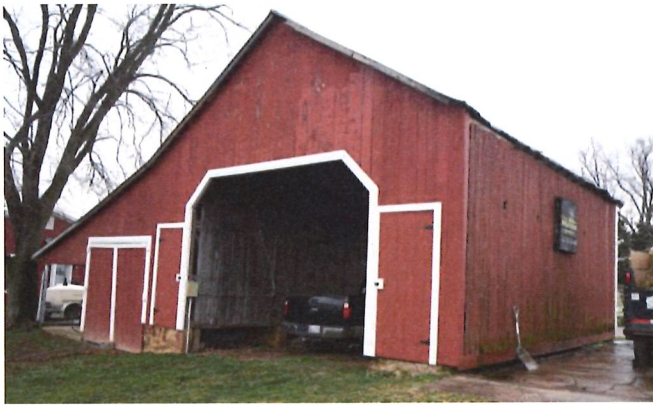
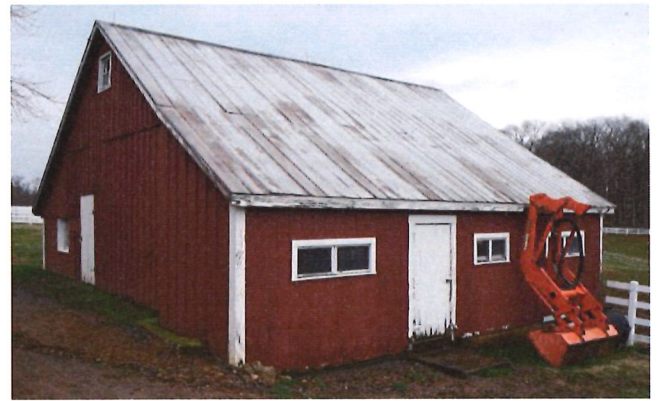
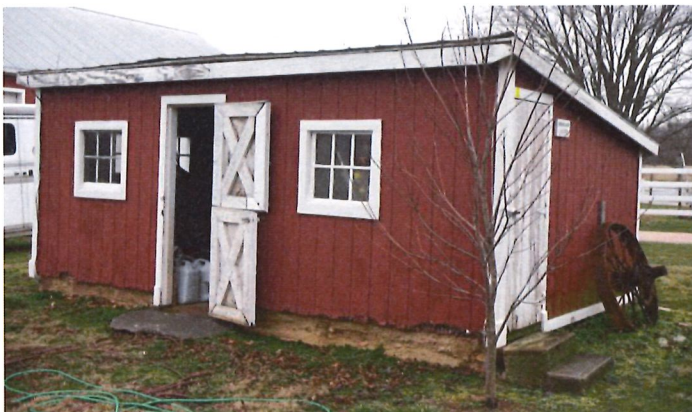
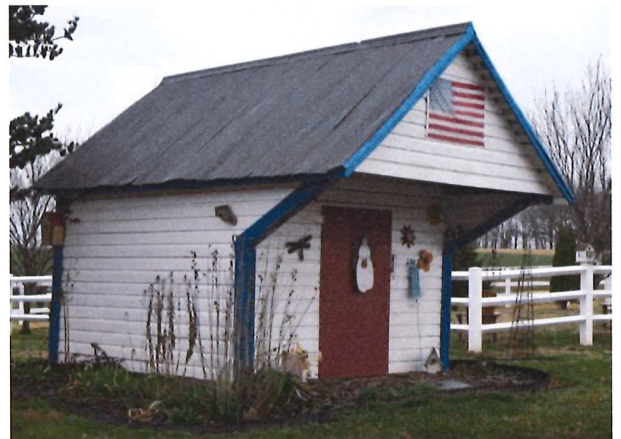
The Duvall Family Farm is located at 2435 Duvall Road, about one mile northwest of Daisy. The historic house was demolished c. 2008-2010 but several historic farm buildings survive, including a smokehouse, wagon shed, hay barn and poultry house. The farm had been in the Talbert family in the late nineteenth century and was reduced from 187 acres to 138 when sold to Samuel and Beulah Davis in 1899. Nine years later they sold to Clinton Duvall who farmed here with his wife Mary until his death in the 1920s. Mary and her young son, John, then took over the farm and Mary left it to him at her death in 1941. John and his wife, Elizabeth, retained the farm until 1960. There were undoubtedly earlier buildings on the farm but these seem to have been replaced, with the existing structures mostly having concrete foundations and wire nails that strongly suggest that the Duvalls embarked on a campaign of farm improvements shortly after acquiring the property. The early twentieth century was one of several periods of intense modernization of farms in the history of central Maryland and the Duvall farm buildings seem to fit within this context. It remained a family farm with a diverse production during the Duvall ownership and the surviving buildings reflect that.
