SUBJECT: T7107

Downtown Patuxent Branch trail Extension

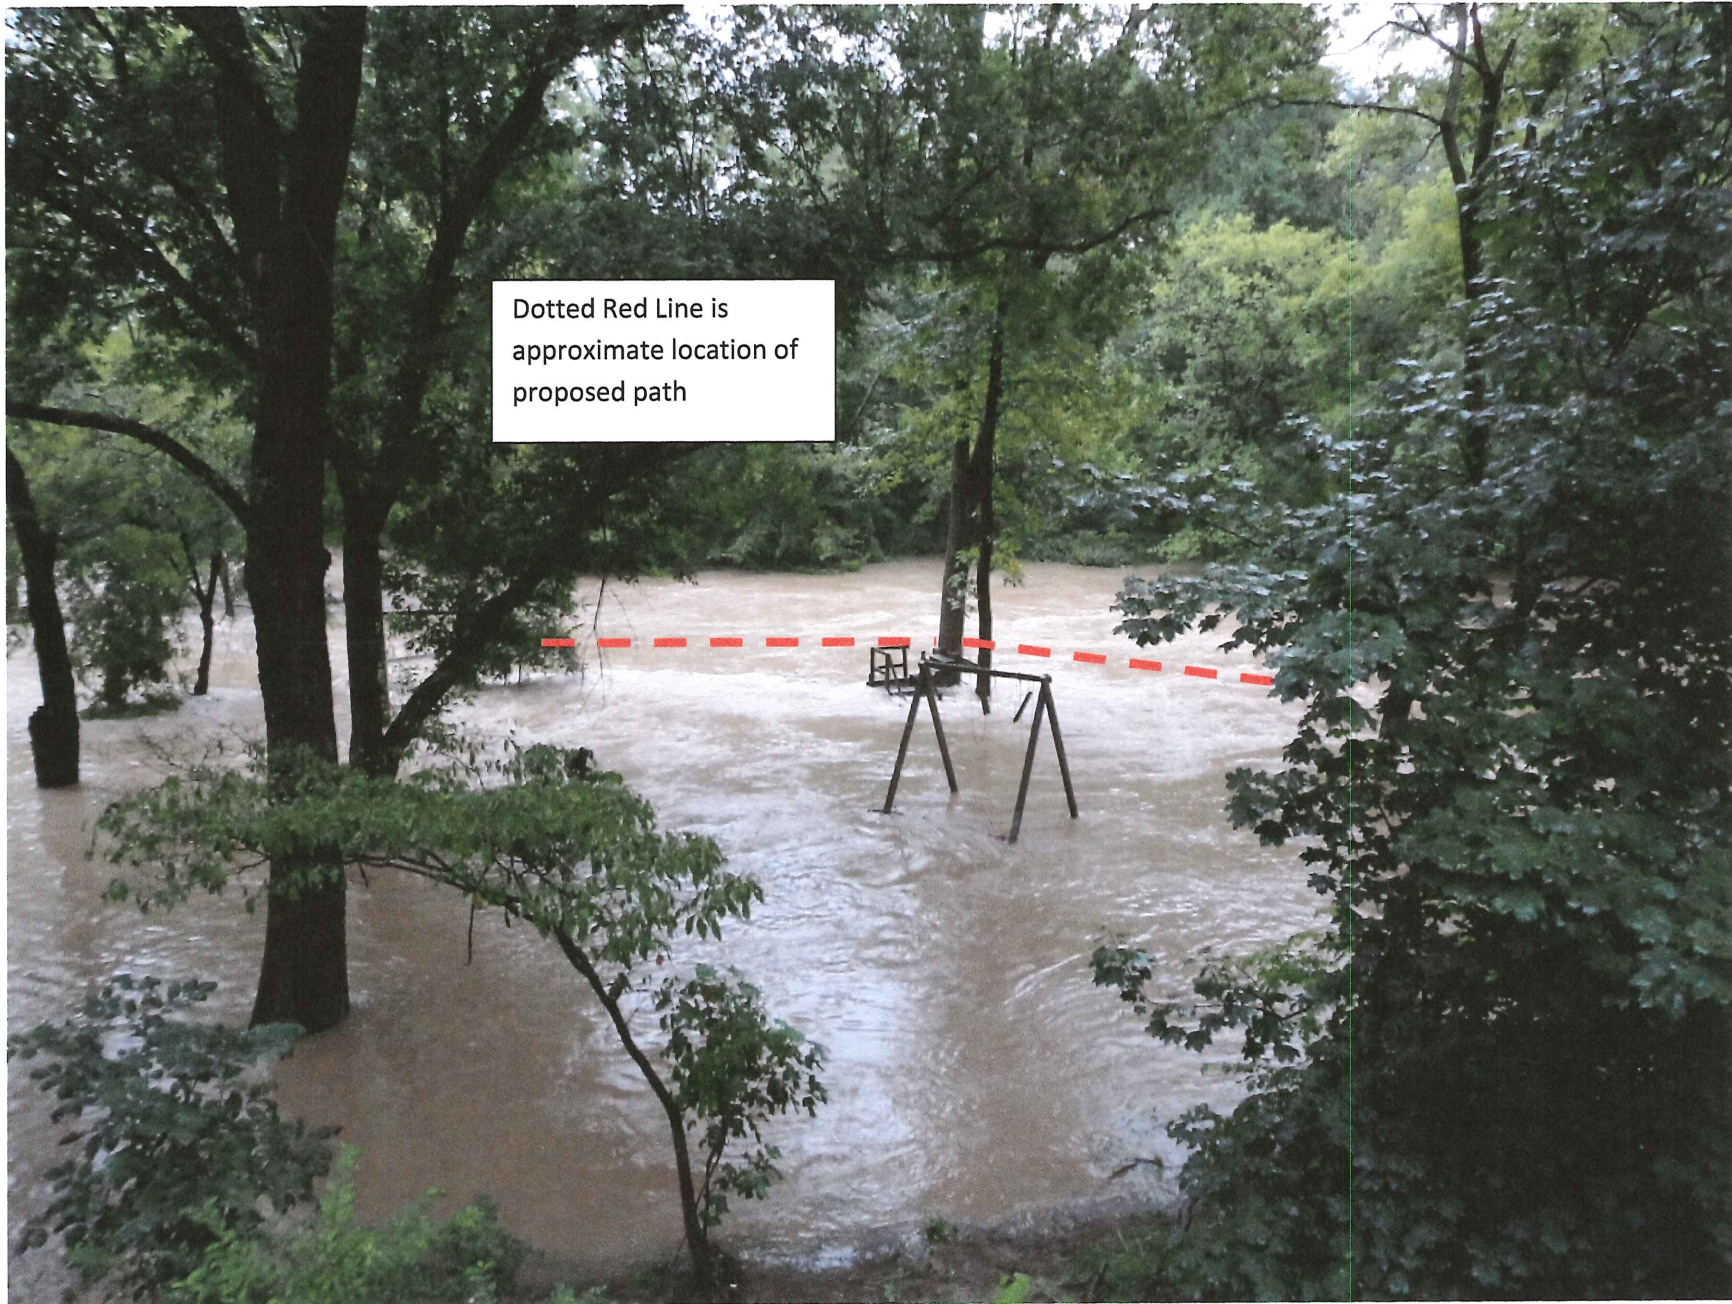
Dotted Red Line is
approximate location of
proposed path

The Little Patuxent river drains Columbia including the mall area resulting in a huge amounts of runoff during storms. Attached is a photo of a flash flood behind my house with 6 feet of water in my yard. The dotted red line is where the path would be. No one could possibly walk, bike, or swim in this flood (Attachment 1-3).

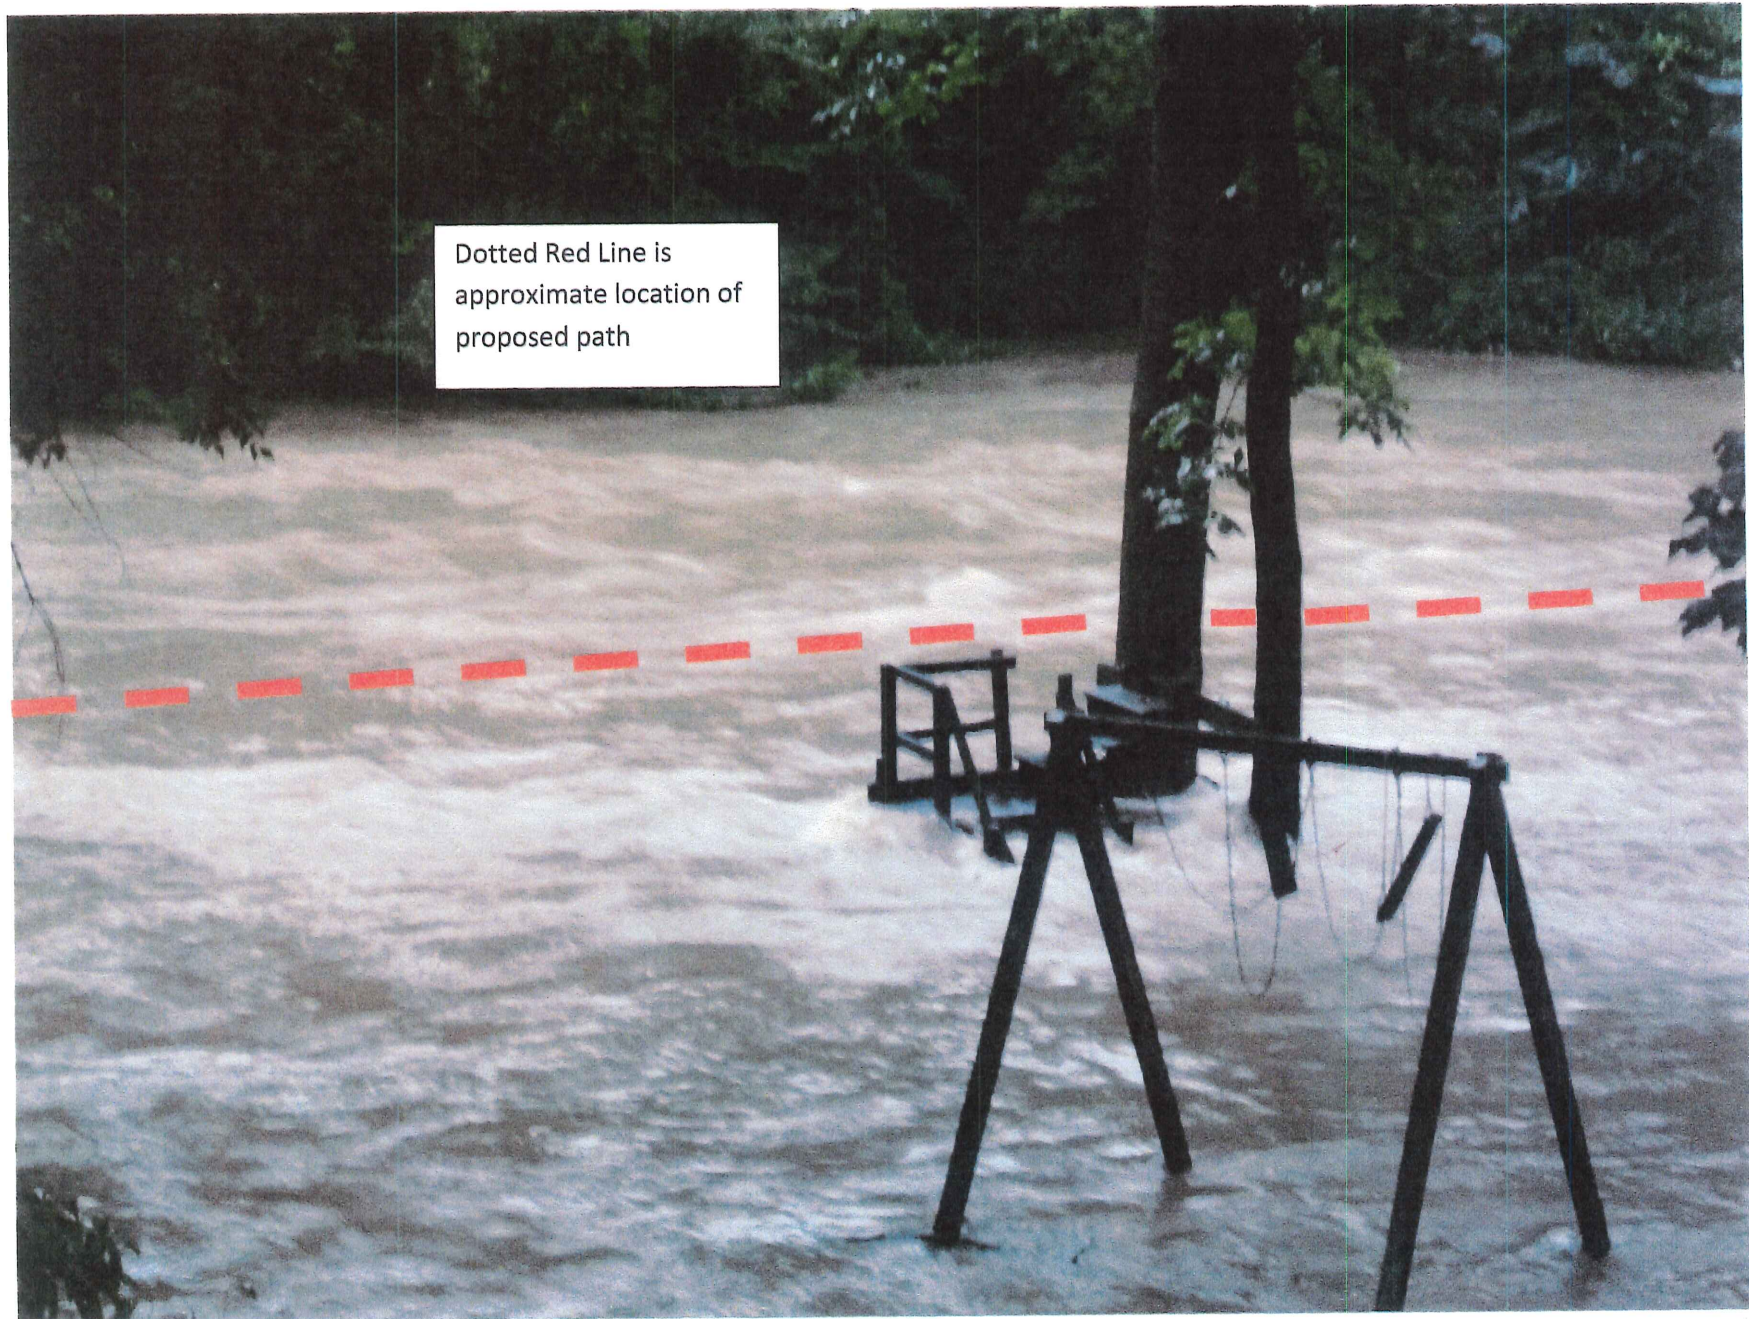
Dotted Red Line is
approximate location of
proposed path

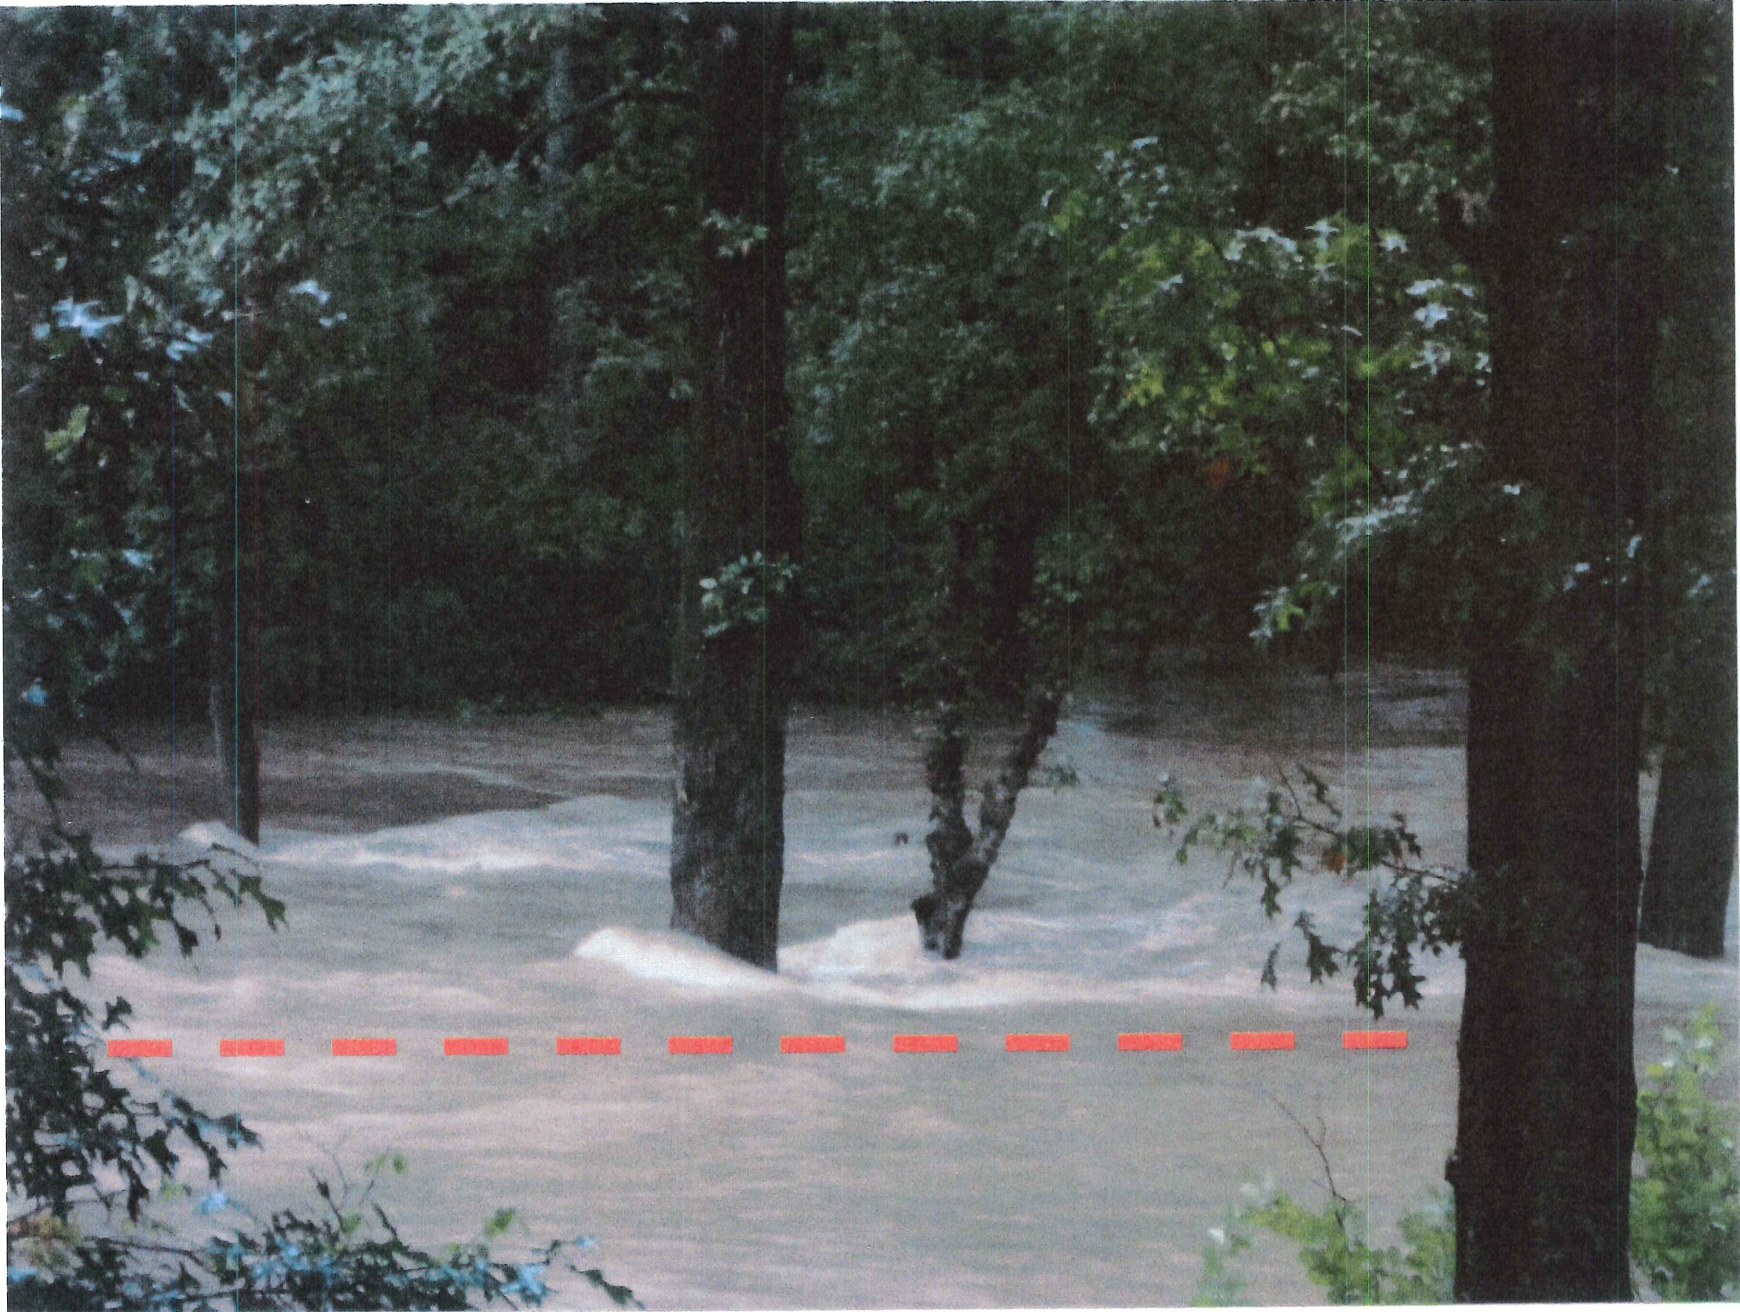
Attachment 4 April 30, 2014 Route 29 & Little Patuxent River Mid-Storm

The proposed path begins south of downtown Columbia and only goes about 200 yards before it crosses under the Route 29 bridge. The Route 29 bridge underpass is by far the most dangerous part of the path because it is only 18 feet wide and the water level is only 2 feet below the bank. Attached is a picture of the Route 29 Bridge underpass that was flooded on April 30, 2014 (see Attachment 4). This picture was taken during the middle of the storm. The proposed path is going under this bridge. At the height of the storm the water was up to the top of the bridge. I couldn't even get to the high side of the bank to take a picture. However, I did take a picture of the water on Route 29 (Attachment 5). Also, the distance between the Route 29 bridge to the ground is only 7 feet which is inadequate. The National Association of DOT's (ASSHTO) requires a 10 foot vertical clearance for a 10 foot path under a bridge.
